# Historic Masonry

## Restoration and Renovation

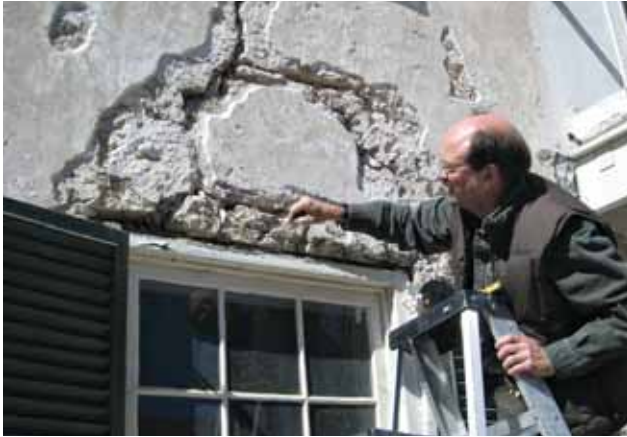
A coquina stone façade on a 1797 Spanish Colonial structure in St. Augustine, Fla., is inspected prior to patching.

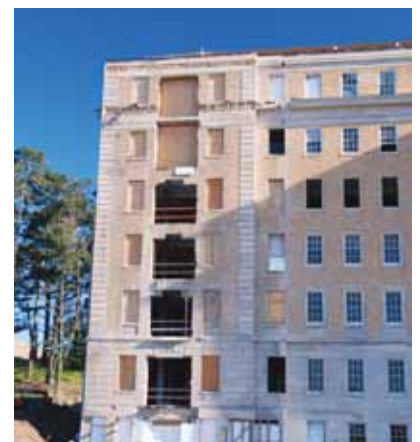
Façade restoration in progress at the historic PHS Hospital. Built in the 1930s, the hospital is being converted into a 22,000-sf apartment building.

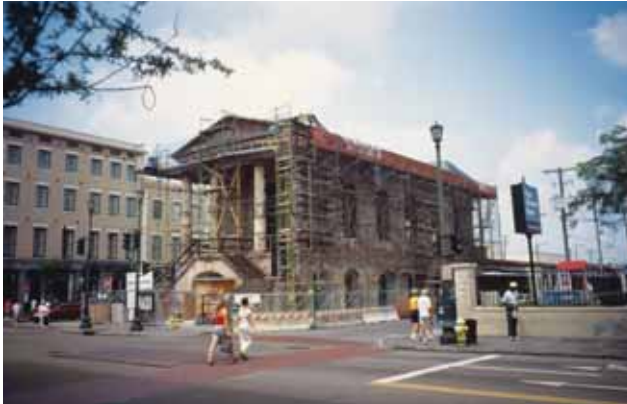
A stucco veneer at Charleston's Market Hall, original constructed in 1841, is being repaired.

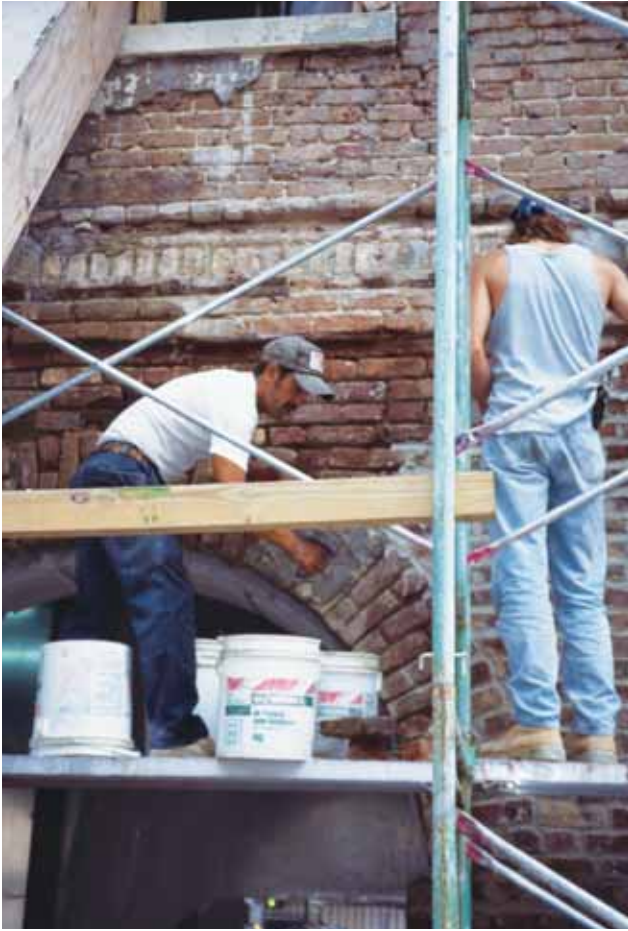
The fine art of repointing arches at Market Hall in Charleston, S.C.

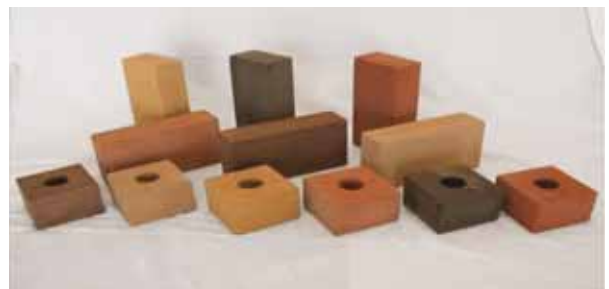
Sustainable bricks manufactured with fly ash have a lower carbon footprint than conventional bricks and come in a variety of colors.

One interesting new product, fly-ash brick, will soon be available for use in construction, says Michael Chusid, RA, FCSI, a principal with Chusid Associates, Tarzana, Calif. He says the product will have about 10% of the carbon footprint of clay brick. "Fly ash is a smokestack waste product, normally disposed of in landfills or retention ponds, so by reusing it as a cementitious material and incorporating it into building products, this stabilizes it and takes pressure off the landfills," he says.
