# Historic Masonry

## Restoration and Renovation

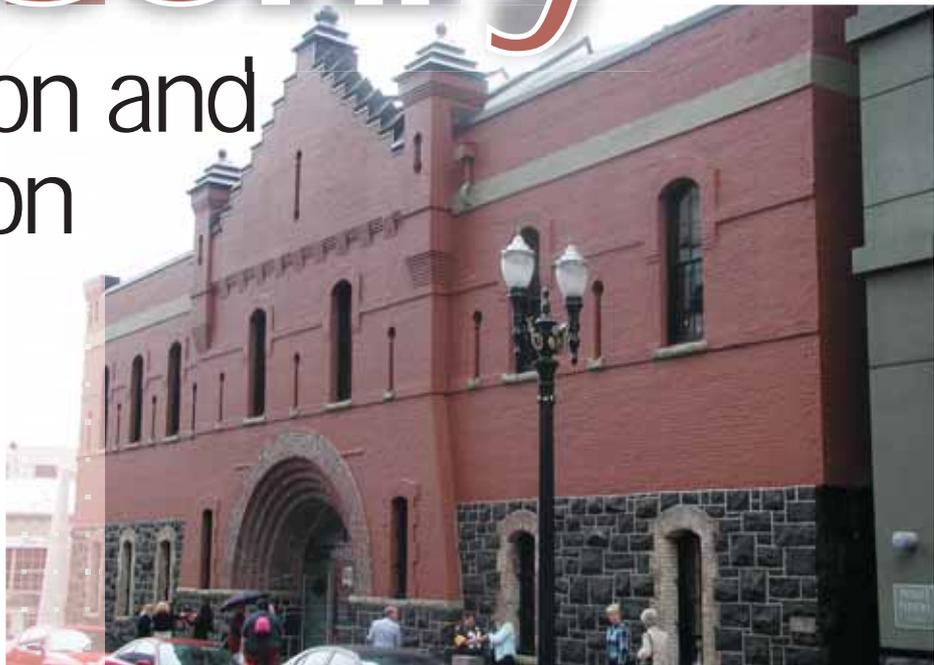
The Gerding Theater at the Armory, in Portland, Ore., the country's first LEED Platinum historic renovation and first LEED Platinum theater, involved extensive brick restoration work. Originally constructed in 1889, it now accommodates a 599-seat main-stage theater and a 200-seat black-box.

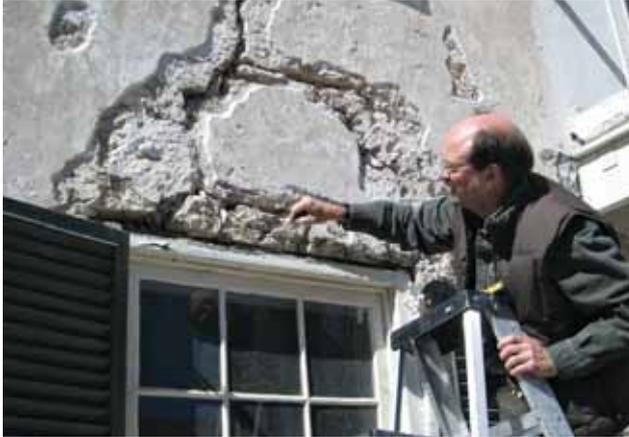
A coquina stone façade on a 1797 Spanish Colonial structure in St. Augustine, Fla., is inspected prior to patching.

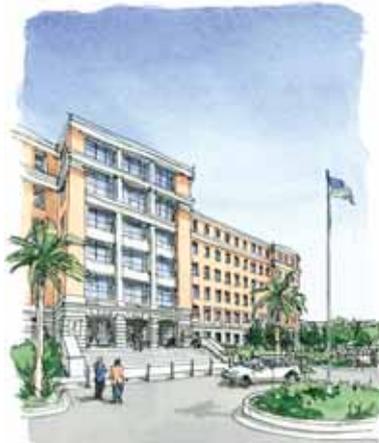
Rendering of Public Health Service Hospital’s rehabbed entry portico.

“We are currently working with the contractor to select appropriate infill materials at areas where historic masonry had been removed in prior renovations of the building,” says Andrew Wolfram, AIA, LEED AP, a senior associate in Perkins+Will’s San Francisco office. Glass-fiber-reinforced polymer panels have been selected to emulate terra cotta and limestone in larger decorative areas. The panels can easily be molded from existing details. However, for smaller areas at a historic entrance portico, “We have found that it is less expensive as an infill material to

use Indiana limestone,” says Wolfram. In order to boost the façade’s energy efficiency, an interior stud wall with insulation has also been specified behind the brick wall.

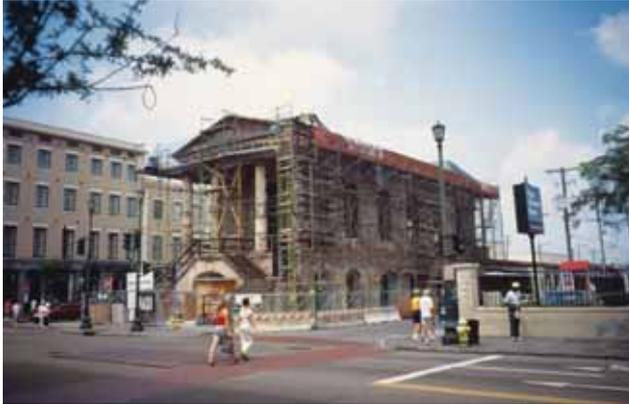
A stucco veneer at Charleston's Market Hall, original constructed in 1841, is being repaired.

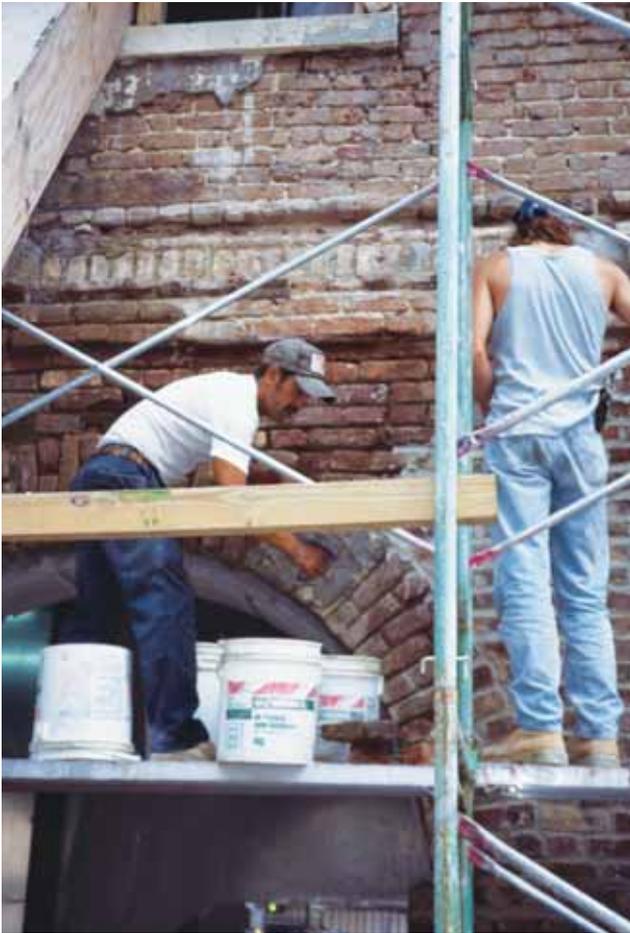
The fine art of repointing arches at Market Hall in Charleston, S.C.

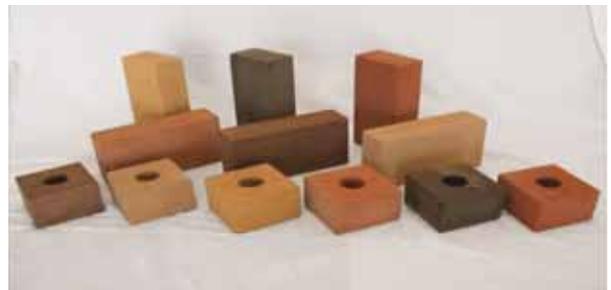
Sustainable bricks manufactured with fly ash have a lower carbon footprint than conventional bricks and come in a variety of colors.

One interesting new product, fly-ash brick, will soon be available for use in construction, says Michael Chusid, RA, FCSI, a principal with Chusid Associates, Tarzana, Calif. He says the product will have about 10% of the carbon footprint of clay brick. "Fly ash is a smokestack waste product, normally disposed of in landfills or retention ponds, so by reusing it as a cementitious material and incorporating it into building products, this stabilizes it and takes pressure off the landfills," he says.
